OPERATION PLUMBBOB

Project 30.7

TEST OF GERMAN UNDERGROUND
PERSONNEL SHELTERS

**TEST OF GERMAN UNDERGROUND
PERSONNEL SHELTERS**

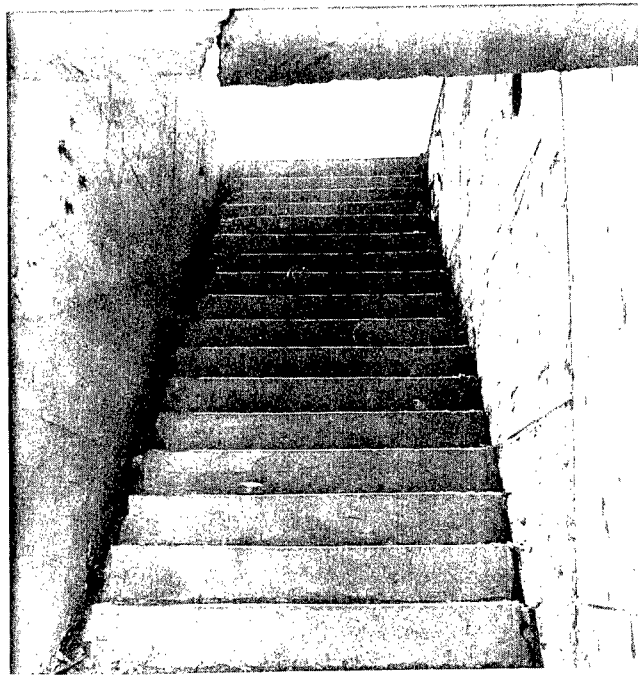
stairs. The exterior wall had several $\frac{1}{32}$ -in. cracks perpendicular to the plane of the stairs located in the upper section of the entrance. The interior wall had a spalled crack located at its quarter point which started at the contraction joint, ran parallel to the stairs, and ended above the sixth riser from the bottom. At the intersection of the top end of the roof slab and the interior wall was a chipped-out section of the wall. This section had two $\frac{3}{32}$ -in. cracks leading out from it and running parallel to the stairs.

Fig. 3.10—Looking up stairs away from GZ (structure RAa).

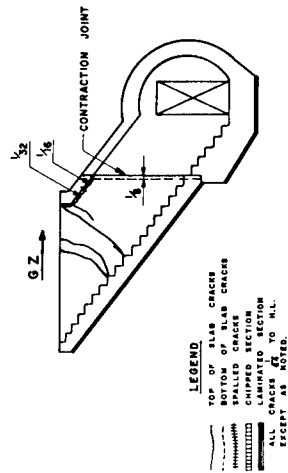
Fig. 3.75—Entrance crack pattern (structure CAb).

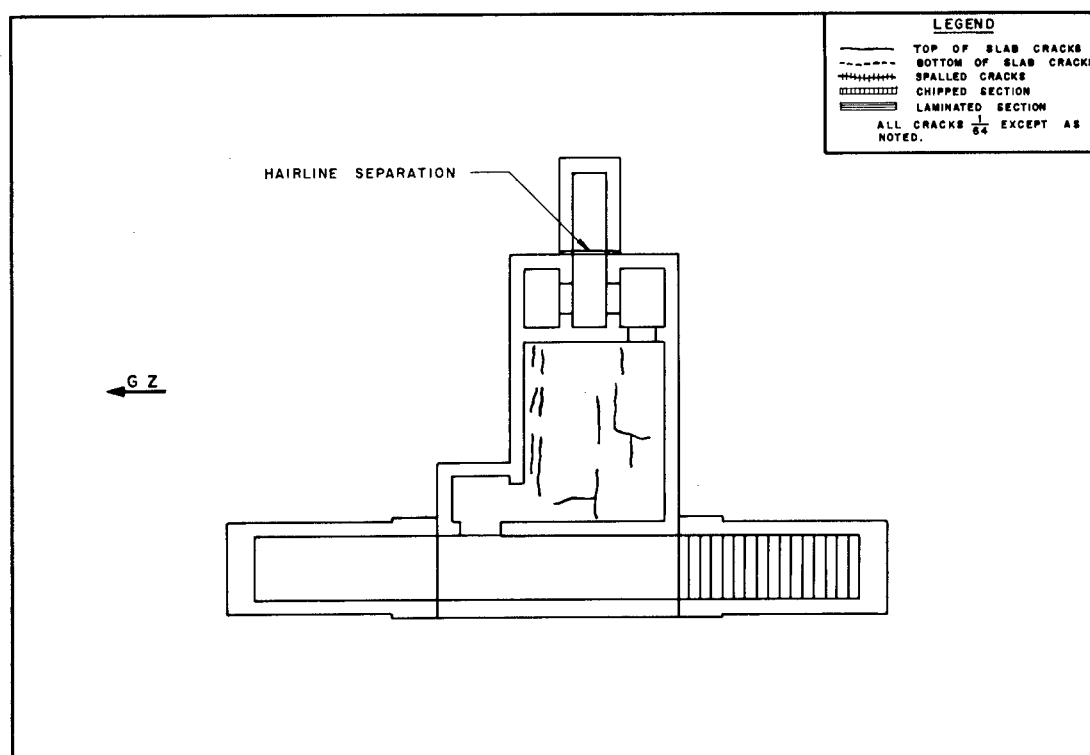
Fig. 3.100—Floor-slab crack pattern (structure RCc).
